**INSPECTION REPORT**  
**Coastal Inspection Service, Inc.**  
**P.O. Box 4628**  
**Salinas, CA 93912**  
**(831) 214-6048**

Report #: 201706-1281  
Dwelling Address: 167 School Way  
Watsonville CA 95076

Client Name: Louise Smith  
Inspector: Chuck Bolner

INSPECTION DATE: June 2, 2017    START TIME: 9:30 AM    STOP TIME: 11:30 AM

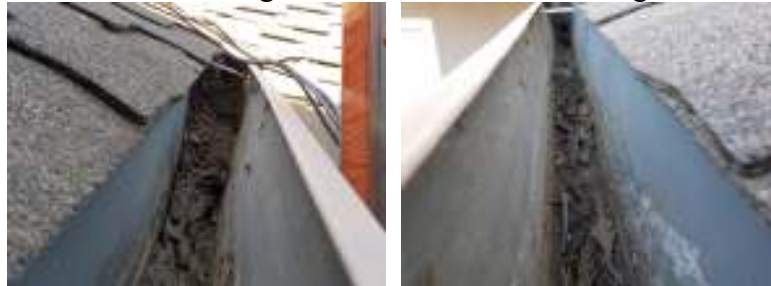
**MAINTENANCE SUGGESTED.** Metal.

Debris noted in the gutters. Recommend cleaning.

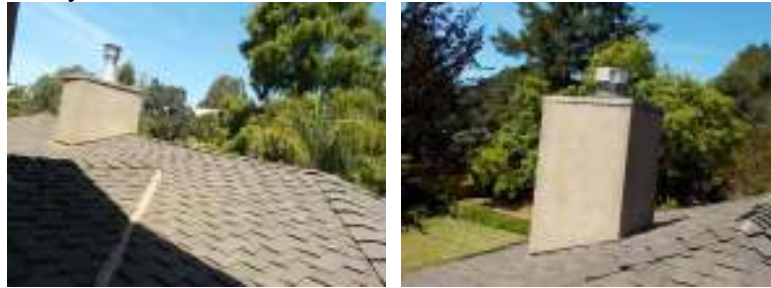
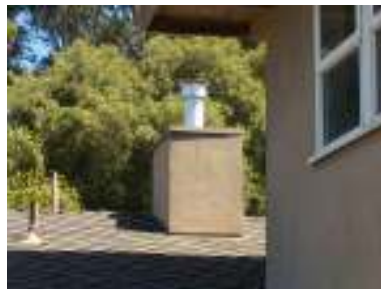
Chimneys/Flues **Serviceable.**  
Three metal chimney pipes are installed and appear to be true and plumb with no visible signs of structure cracking.  
PLEASE NOTE: INSPECTION OF THE FLUE LININGS IS OUTSIDE THE SCOPE OF THIS INSPECTION.  
A qualified chimney contractor can be contacted to evaluate this portion of the chimney.  
A spark arrestor is installed on each metal chimney pipe as a safety feature.

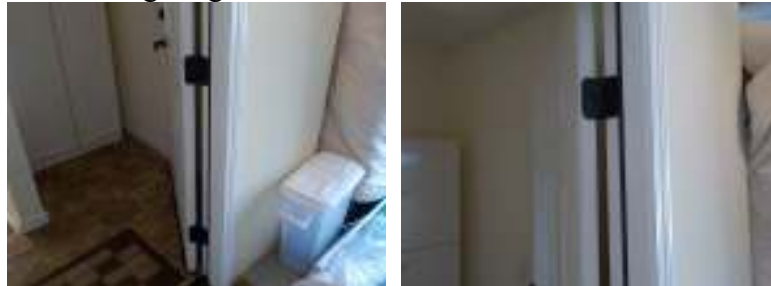
Fire Door                    **REPAIRS ARE RECOMMENDED.**  
Self closing hinges are needed.

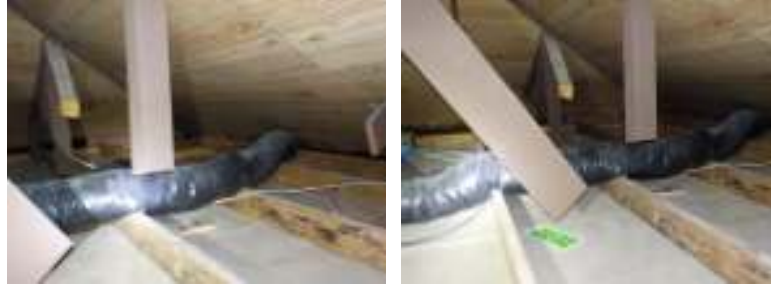
**COMMENTS.** 2 x 6 rafters.  
Cut rafters noted in remodeled areas above the bedroom.

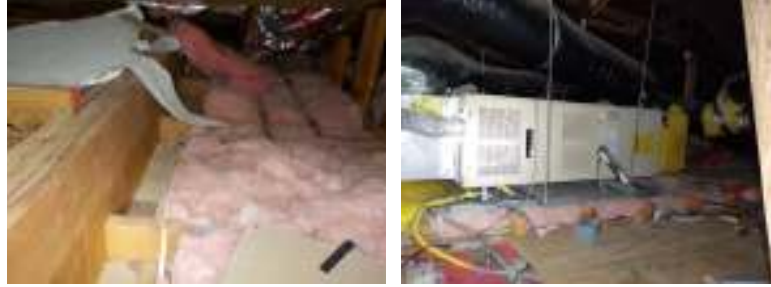
No continuous path noted to the attic mounted furnace.  
Recommend installing a walkway to the furnace.

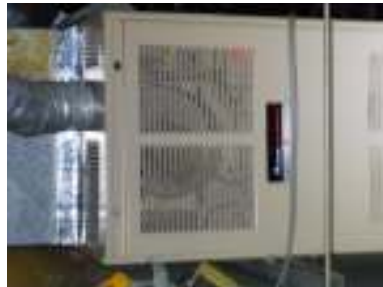
A Amana brand, propane gas, forced air unit is installed in the lower attic.

**Serviceable.** Unit is clean.

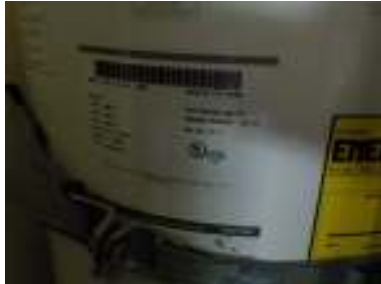
**Description**      **Serviceable.** American Standard brand, 50 gal, Electric type.  
Located in the garage.  
A gas shut off is installed near the water heater as a safety consideration.

**Conditions**      **Serviceable.** Unit was built in 2010.

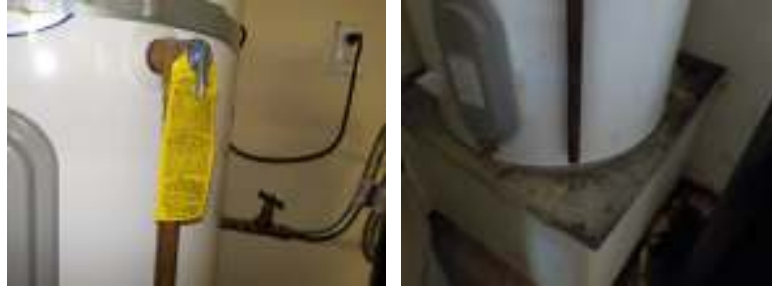
Temperature pressure relief valve with drain line installed as a safety device.

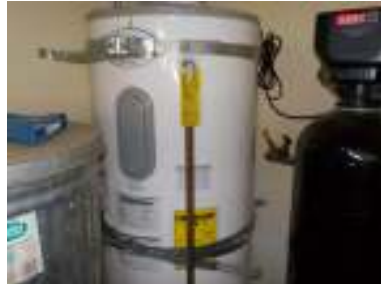
The water heater has been secured to the wall using two seismic straps of 3/4" width or greater and 20 gage or greater metal.

The strapping method appears to conform to the requirements of the California Office of the State Architect.

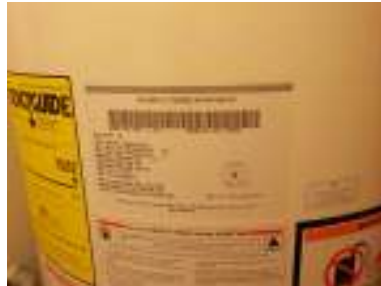
**Description**                    **Serviceable.** American Standard brand, 50 gal, Electric type. Located in the upper attic. A gas shut off is installed near the water heater as a safety consideration.

**Conditions**                    **Serviceable.** Unit was built in 2013.

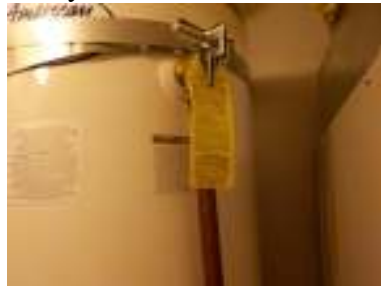
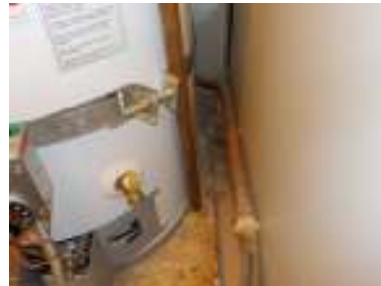
**Pressure Relief System**    **Serviceable.** Temperature pressure relief valve with drain line installed as a safety device.

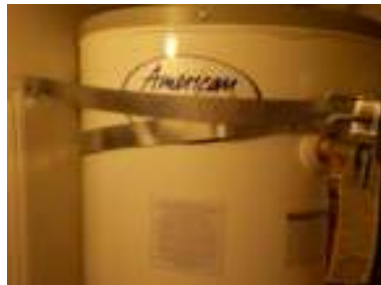
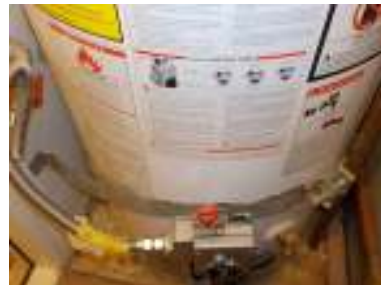
**Earthquake Bracing**        **Serviceable.** The water heater has been secured to the wall using two seismic straps of 3/4" width or greater and 20 gage or greater metal. The strapping method appears to conform to the requirements of the California Office of the State Architect.

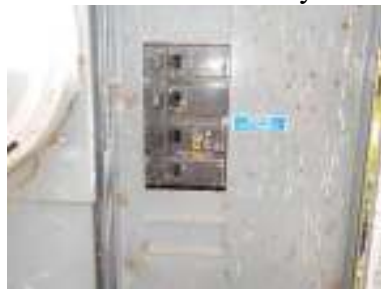
**Serviceable.** 200 amp, Underground.  
Located at the driveway at the front of the property.

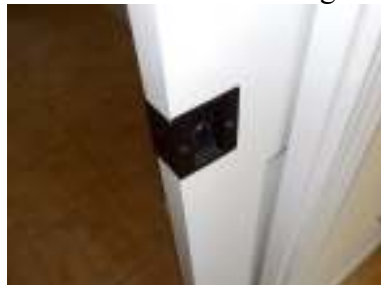
Doors                                  **MAINTENANCE SUGGESTED.**  
Latch noted on the wrong side of the pocket door.

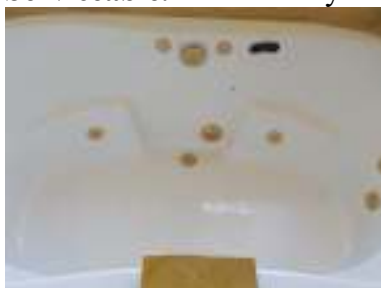
Tub                                **Serviceable.** Jacuzzi style tub installed.

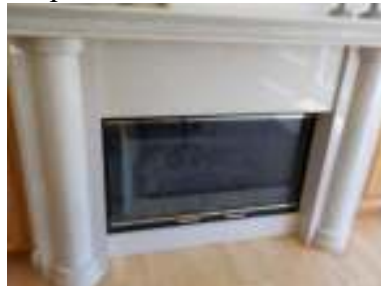
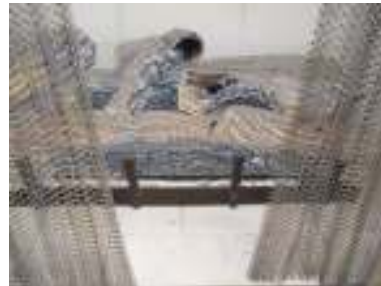
- Fireplace                         **Serviceable.** Prefab unit, Gas burning, Marble front.  
Fireplace is clean.

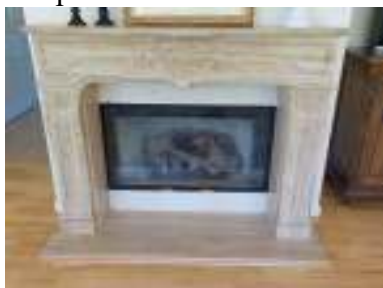
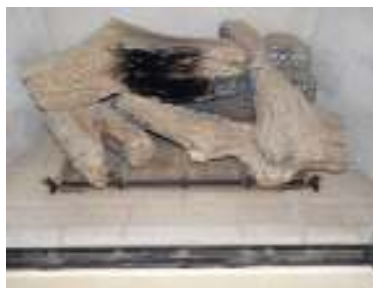
Floors	<b>Serviceable.</b> Hardwood veneer.
Walls	<b>Serviceable.</b>
Ceilings	<b>Serviceable.</b>
Doors	<b>Serviceable.</b>
Windows	<b>Serviceable.</b>
Electrical	<b>Serviceable.</b>
Fireplace	<b>Serviceable.</b> Prefab unit, Gas burning, Marble front. Fireplace is clean.

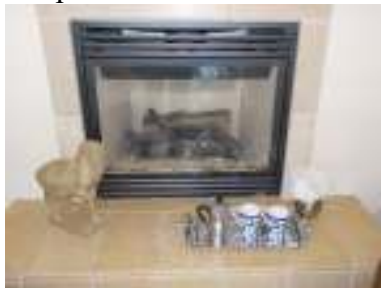
Fireplace                      **Serviceable.** Tile front. Prefab unit. Gas burning.  
Fireplace is clean.
