**INSPECTION REPORT**  
**Coastal Inspection Service, Inc.**  
**P.O. Box 4628**  
**Salinas, CA 93912**  
**(831) 214-6048**

Report #: 201706-1281  
Dwelling Address: 167 School Way  
Watsonville CA 95076

Client Name: Louise Smith  
Inspector: Chuck Bolner

INSPECTION DATE: June 2, 2017    START TIME: 9:30 AM    STOP TIME: 11:30 AM

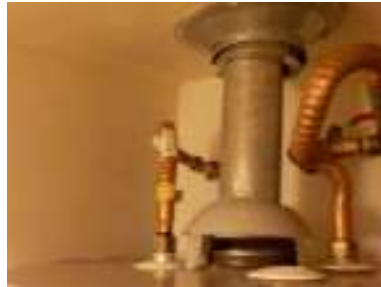
Venting

**Serviceable.**
